Subject: Report of Geotechnical Investigation and Engineering
Proposed Plat Development
Intersection of HW 9 & SR 531, Arlington, WA
Parcel #31052400302000

GEOTECHNICAL INVESTIGATION AND ENGINEERING REPORT

PROPOSED SINGLE FAMILY RESIDENTIAL REDEVELOPMENT

PARCEL #31052400302000,
ARLINGTON, WA

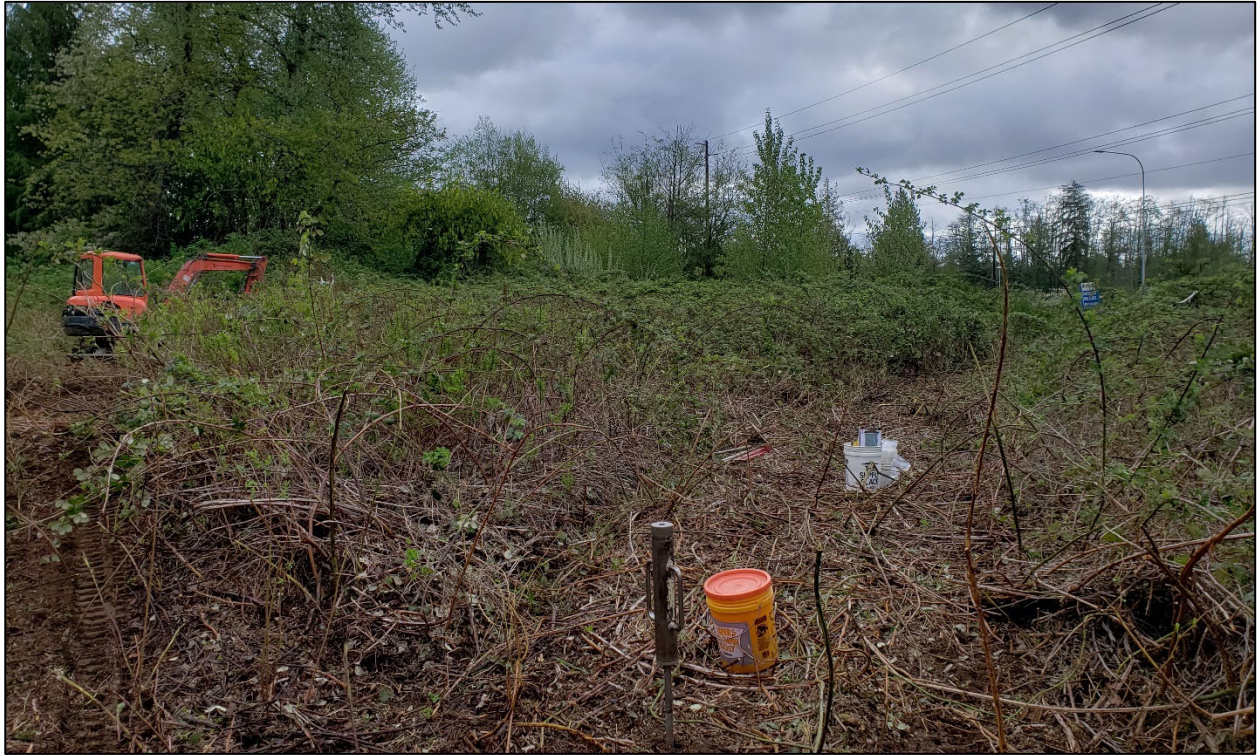
Photo A: Overview of project site, looking east from the central-southern end of proposed improvement area. Test Pit 1 in background, and DCP-2 in progress.

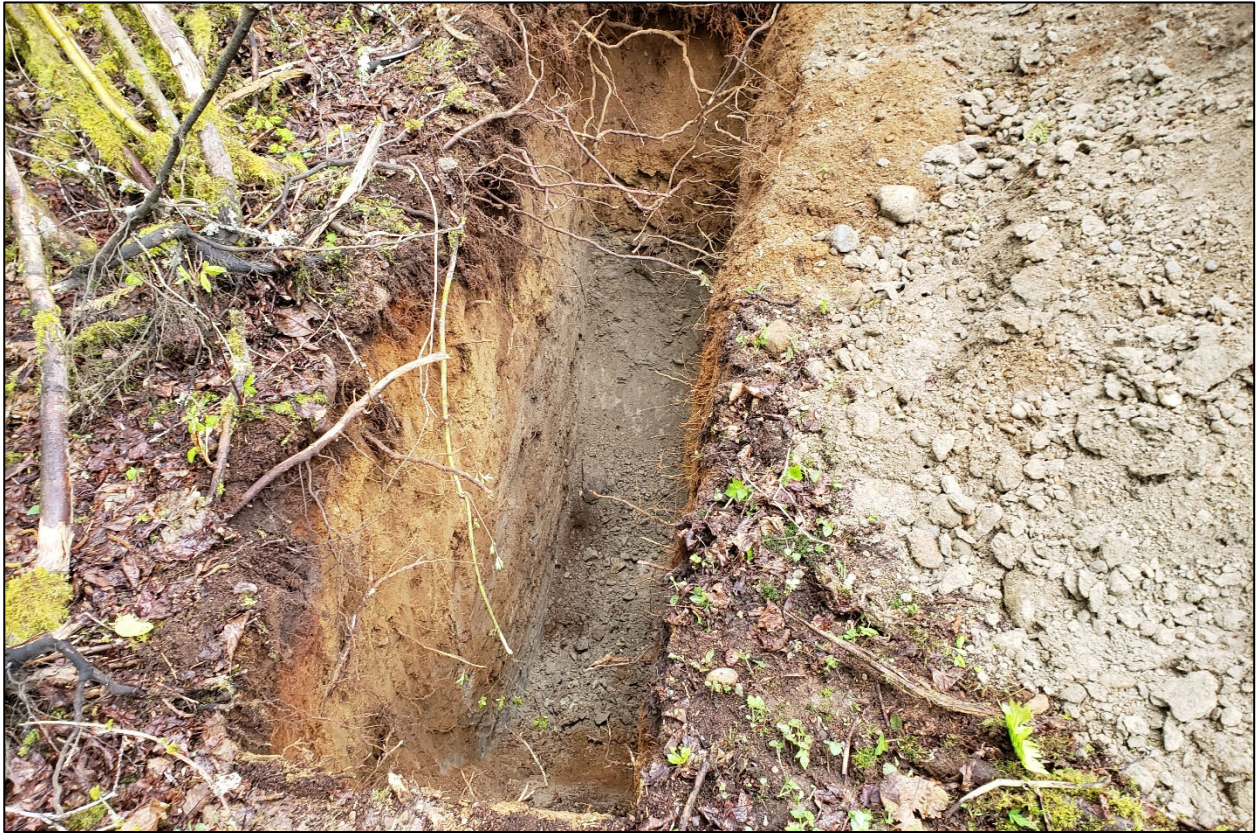
Photo C: Test Pit TP-14 excavated. Note consolidated gray unit at about 2.5 feet BPG.

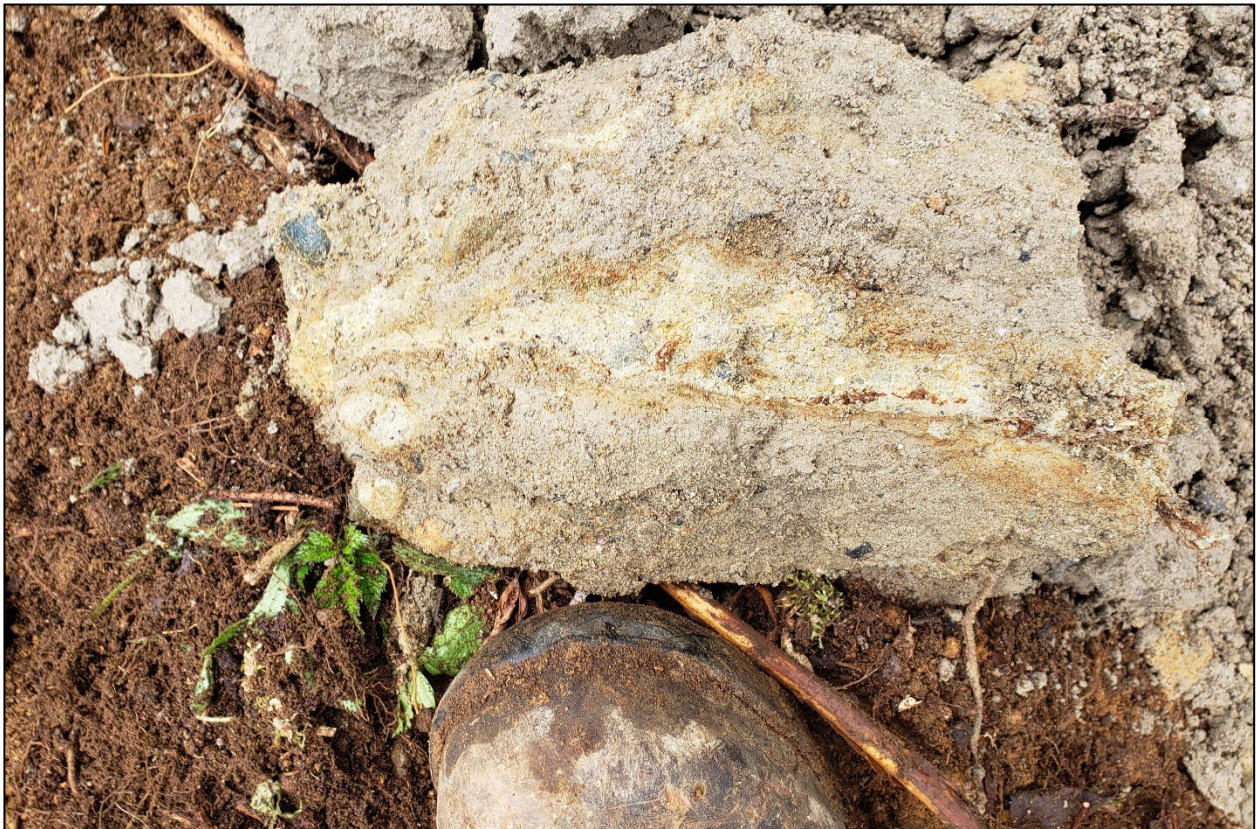
Photo D: Representative image of small-scale sand lenses observed locally within the Glacial Till.

Soils interpreted as native glacial till underlie the subsoil and were consistently observed in all locations. The unit ranged from coarse grained and gravelly to a finer grained sandy silt. This sand unit was moist and generally loose becoming medium dense with depth. In some areas, local seepage was observed within this unit.
